VISVESVARAYA NATIONAL INSTITUTE OF TECHNOLOGY  
South Ambazari, Road, NAGPUR – 440 010 ( INDIA )

DEPARTMENT OF CIVIL ENGINEERING

The Amt. Z.P. Shikshak Sahakari  
Bank Ltd. Amravati R. No.116

**Subject:** Structural audit of Head Office Bank Building at Amravati

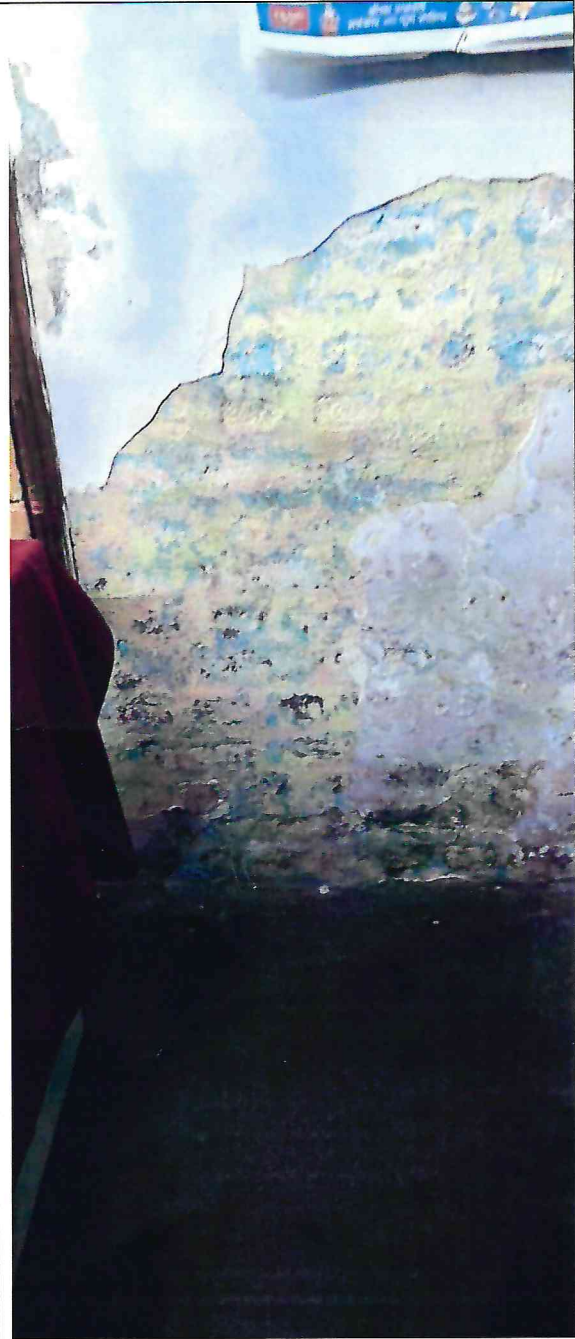
- The heavy dampness can be seen in right hand side of wall from inside as well as outside. This wall is load bearing. Due to dampness the plaster from inside & outside is started falling down. Please refer Photograph No. 2,3,4 & 5.
- The chajjas from both side and on all floors are deteriorated badly. Bottom concrete cover is falling down and reinforcement exposed at many locations. At one location chajja is completely fall down. Please refer Photograph No. 6,7 & 8.
- The outside columns are cracked. Please refer Photograph No. 9 & 10.
- Some of the beams are cracked. Please refer Photograph No. 11, 12 & 13.
- Dampness in slabs at some location is observed. Also, concrete cover falls down and reinforcement exposed. Please refer Photograph No. 14, 15 & 16.

**Photo 3: Falling of inside plaster**

- i. From visual inspections, it is observed that condition of building is deteriorated. Cracks are developed in structural members like columns & beams.
- ii. Dampness is observed in right side load bearing wall which carrying the half load of the building. Falling of plaster and concrete cover of structural elements are warning before failure.
- iii. UPV test indicates that concrete quality of structural members is poor.
- iv. The results of rebound hammer test indicate that the concrete strength is moderate (but not good).
- v. It is concluded that the durability and stability of existing building is poor as it is showing all indications before major failure.
- vi. It is recommended to demolish the building to the earliest to avoid any major mishap.

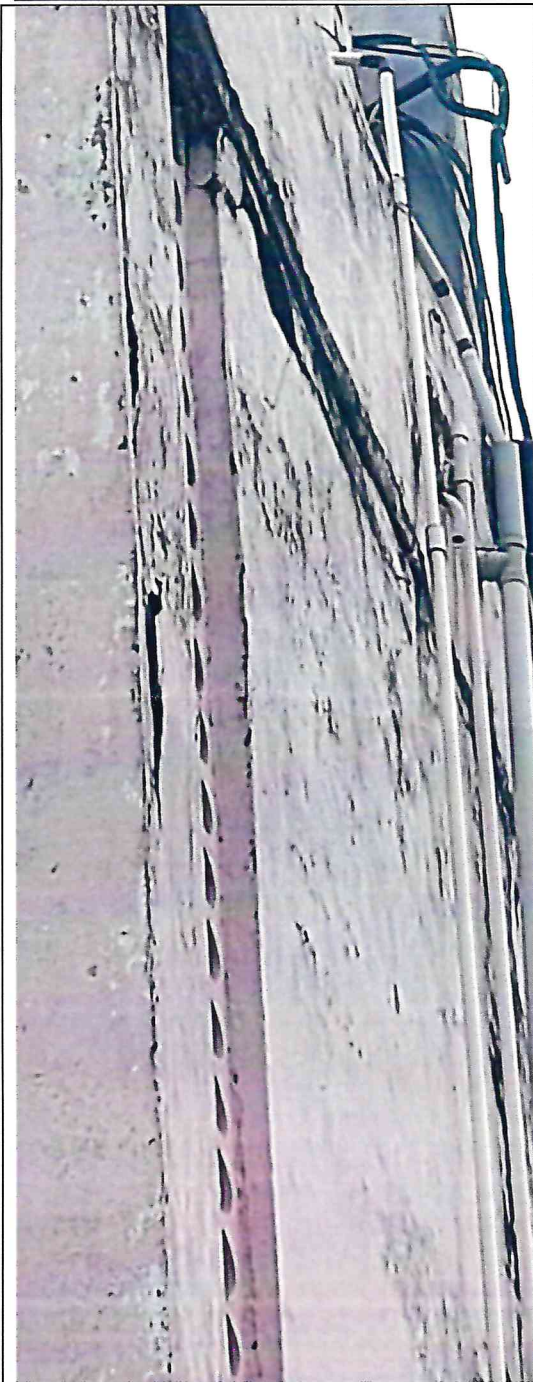
**Photo 4: Dampness in wall from out side**

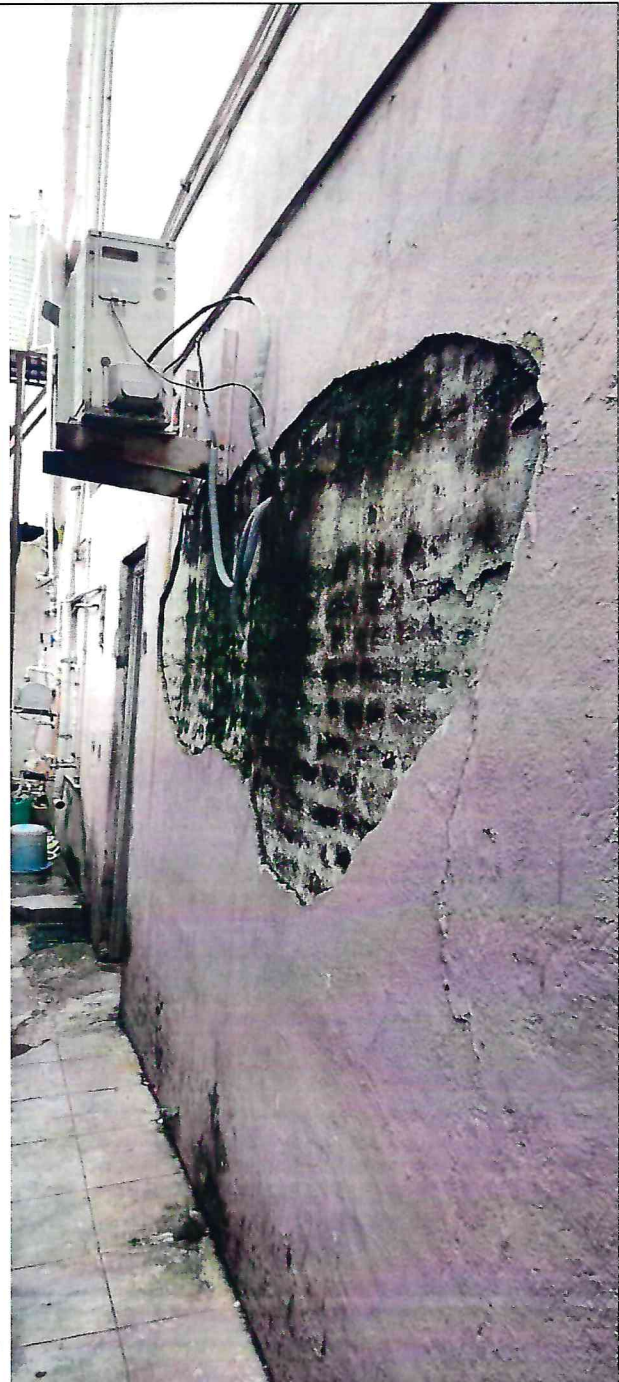
**Photo 5: Falling of outside plaster**

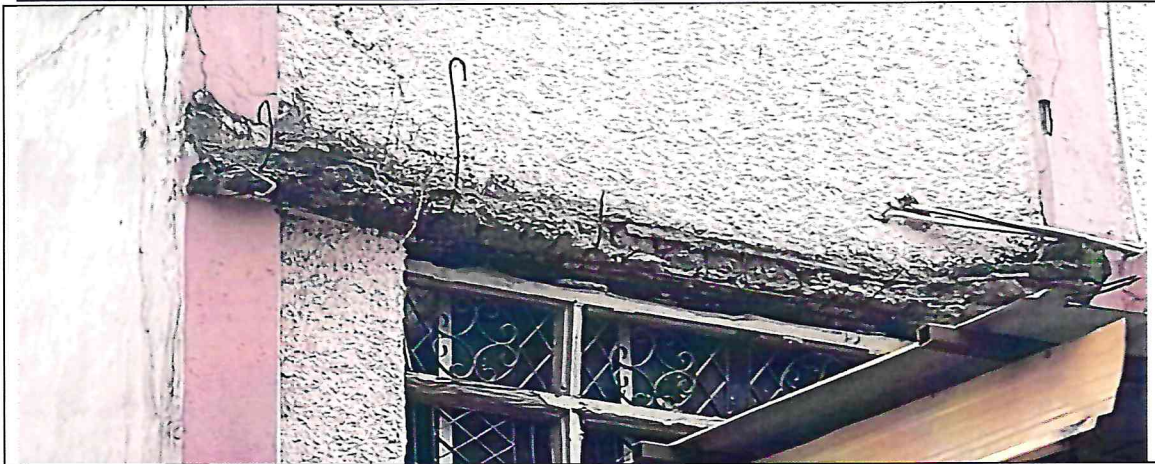
**Photo 6: Chajja fall down completely**

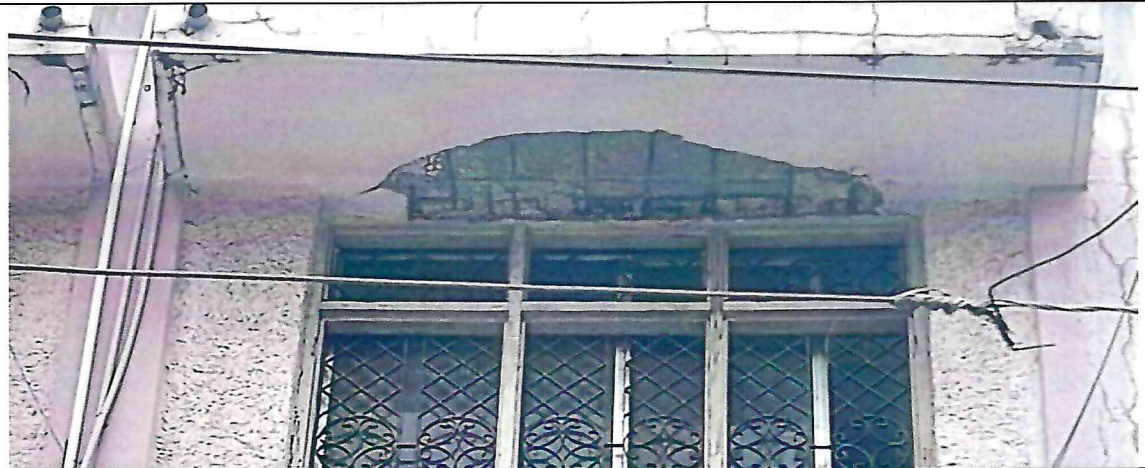
**Photo 7: Chajja reinforcement exposed**

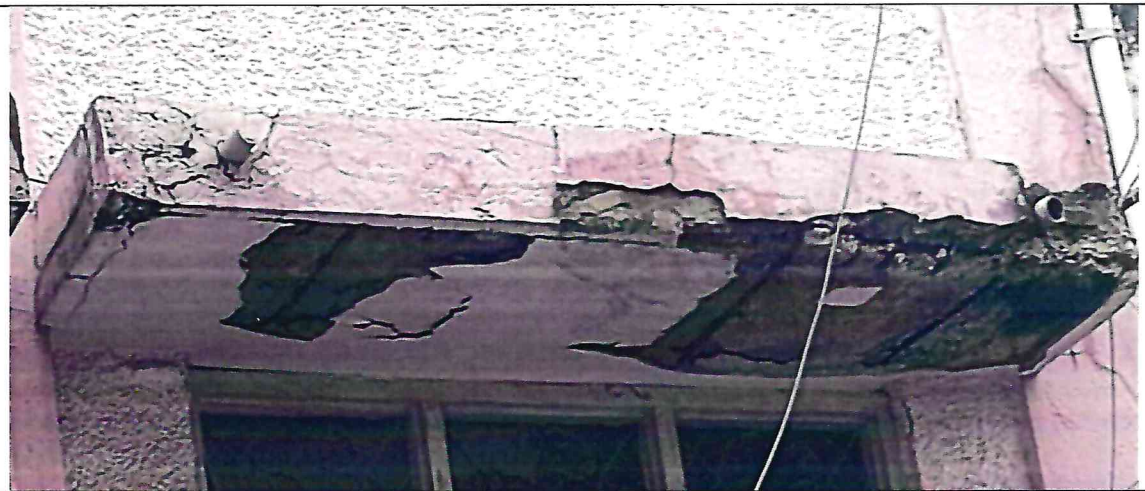
**Photo 8: Chajja reinforcement exposed**

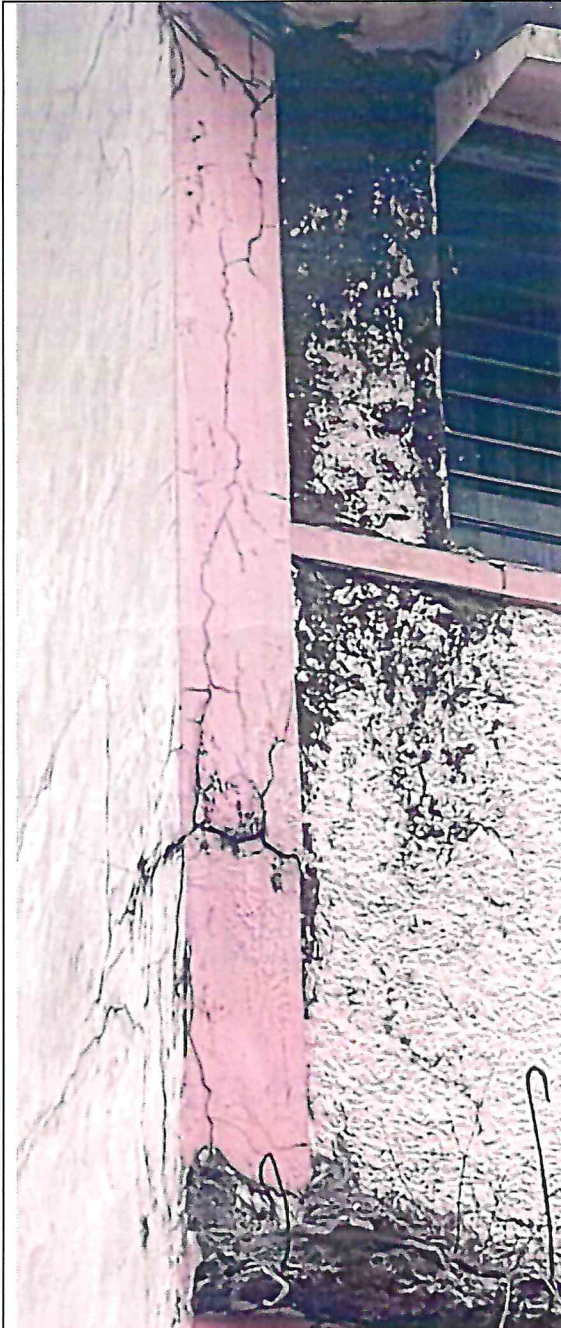
Photo 9: Cracks in column

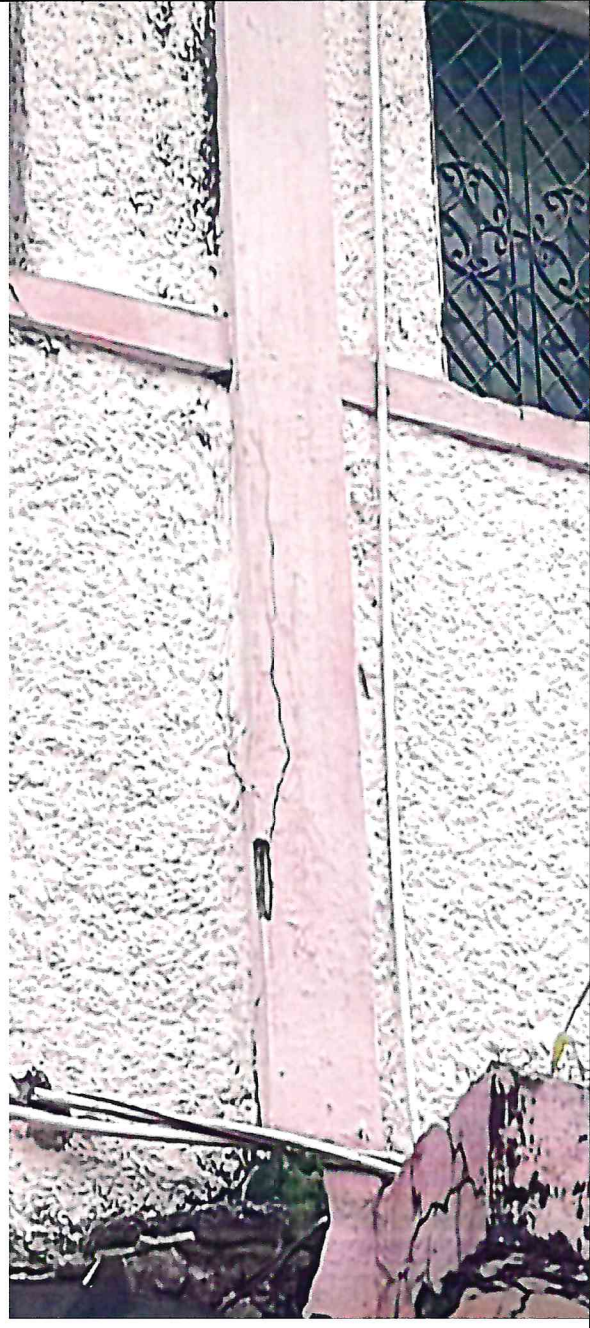
Photo 10: Cracks in column

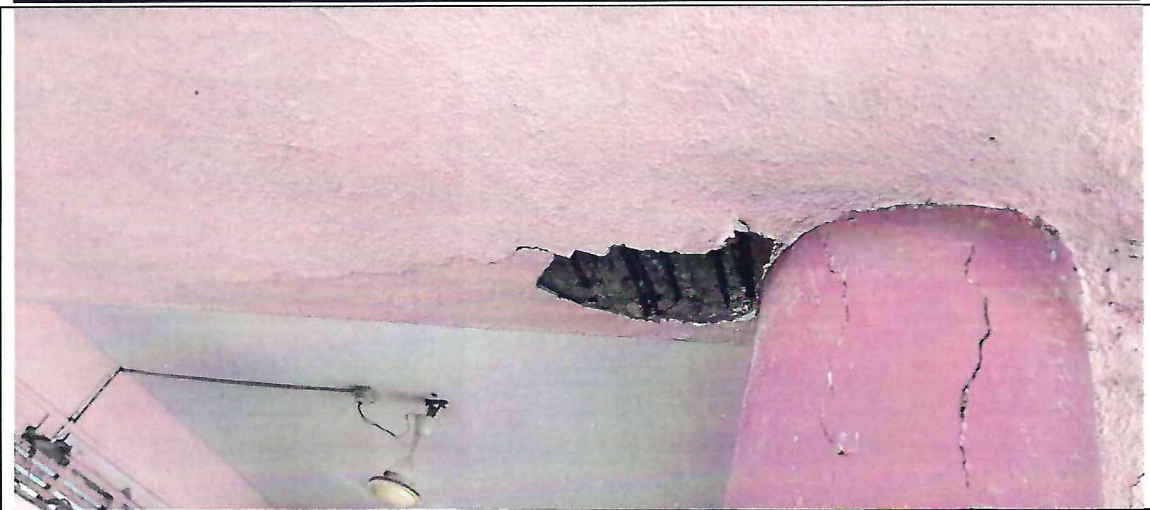
**Photo 11: Cracks in column & Beam. Beam Reinforcement exposed.**

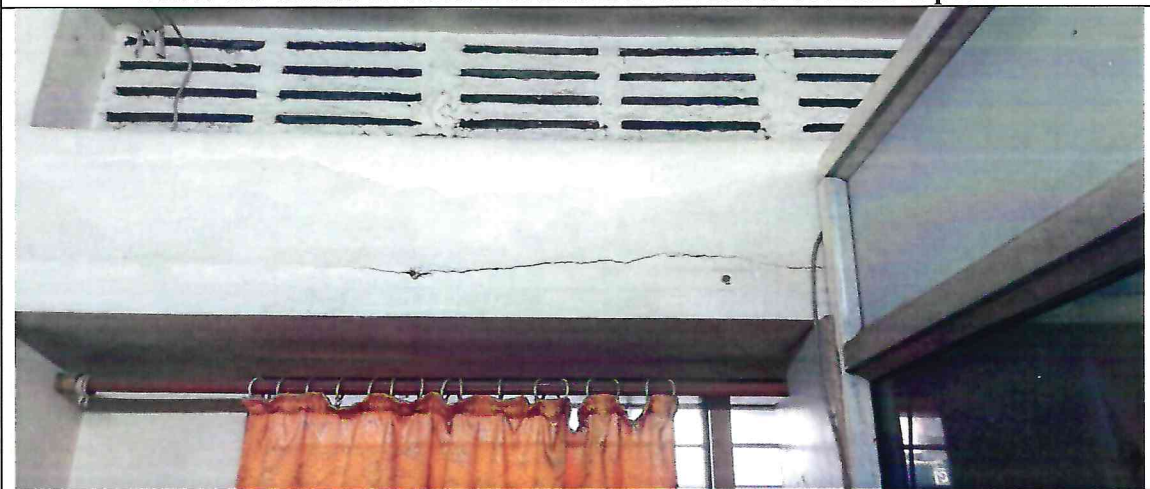
**Photo 12: Crack Lintel Beam**

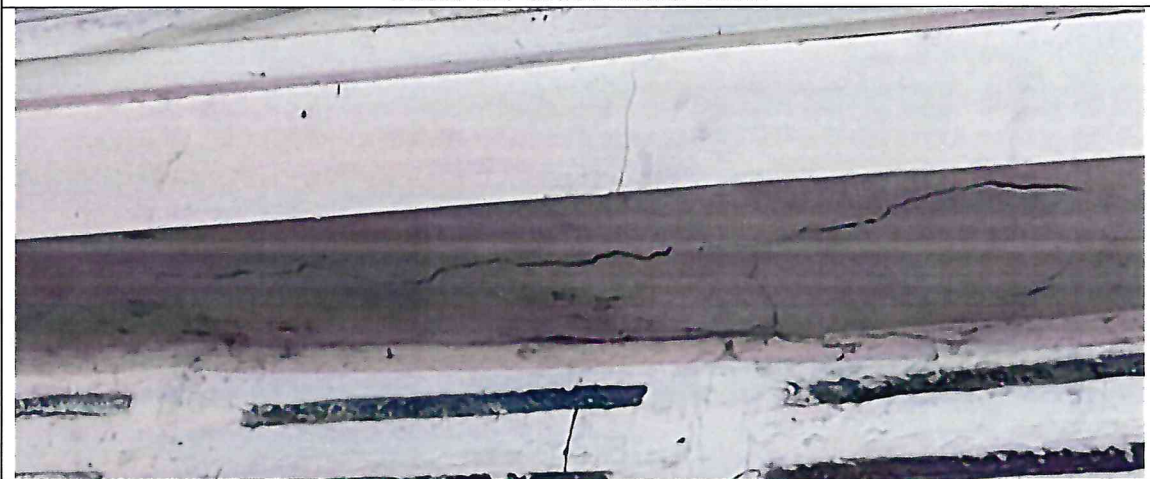
**Photo 13: Crack slab level Beam**

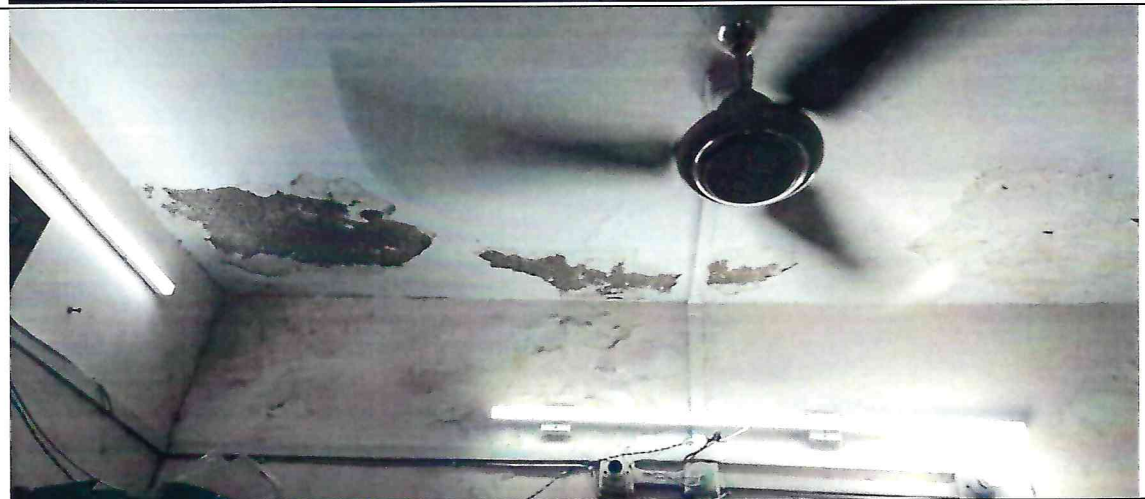
**Photo 14: Dampness in slab in Cashier room**

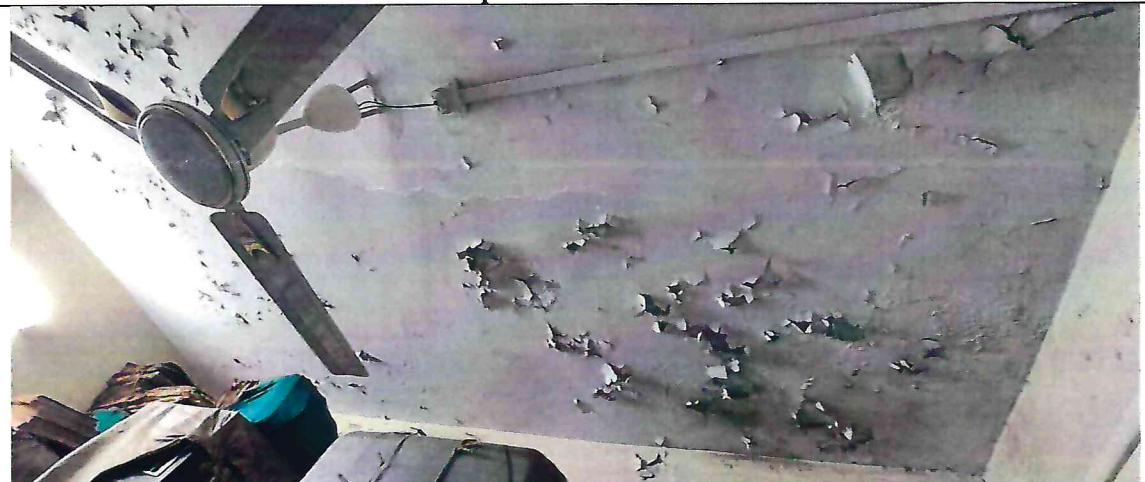
**Photo 15: Dampness in slab in Locker room**

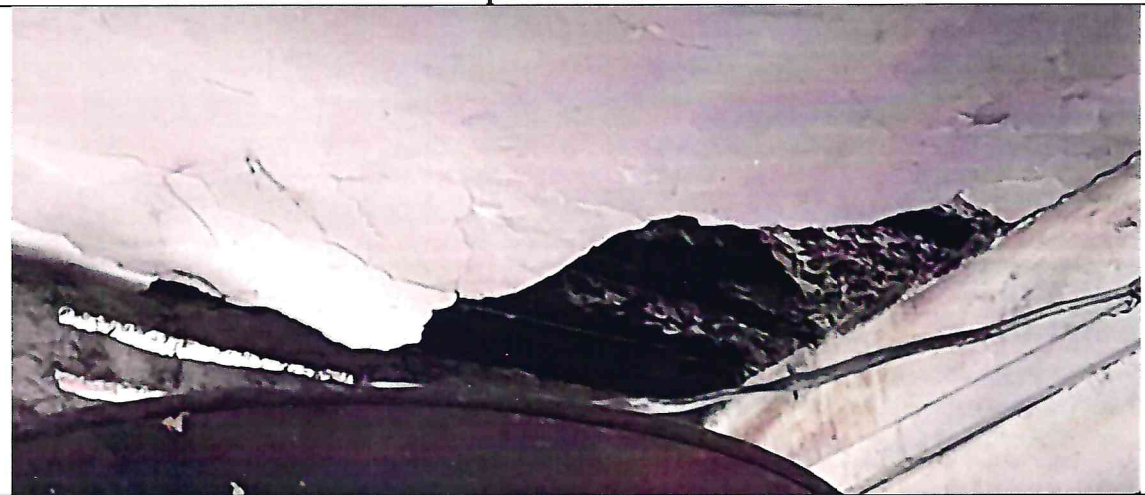
**Photo 16: Exposed reinforcement of slab in front verhandaha**
